Electrical Service

None of the tips offered here is particularly exotic or high-tech. But most have at least a little to do with good connections. The Toyota In-line Fuse Location Chart should save you some diagnostic time too.

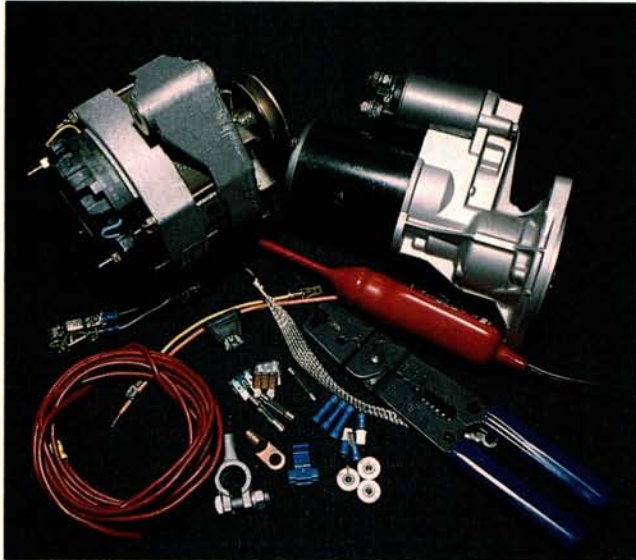
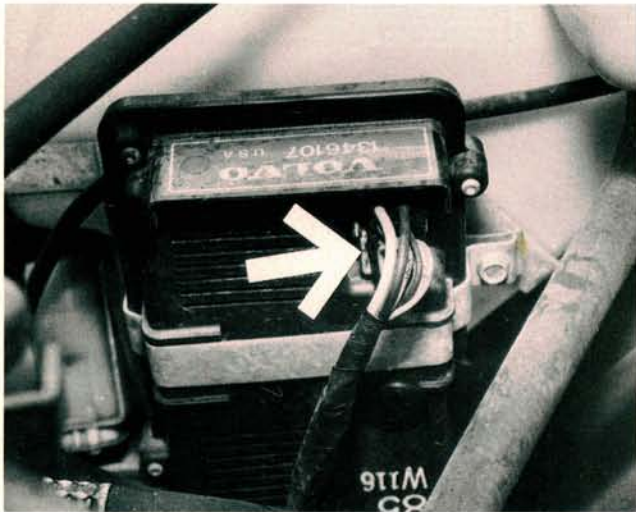
Volvo Ignition System Cable Harness

Several different ignition control units and cable harnesses have been used on 240-series Volvos since the 1980 model. You may need to make some changes when replacing either one. If you use a new harness with an old ignition control unit, the female pin sleeves on control unit terminals 3, 5, and 9 must be removed. When using a new control unit with an old harness, sleeves must be installed on these same control unit terminals, or you'll end up with a loose connection and a no-start condition.

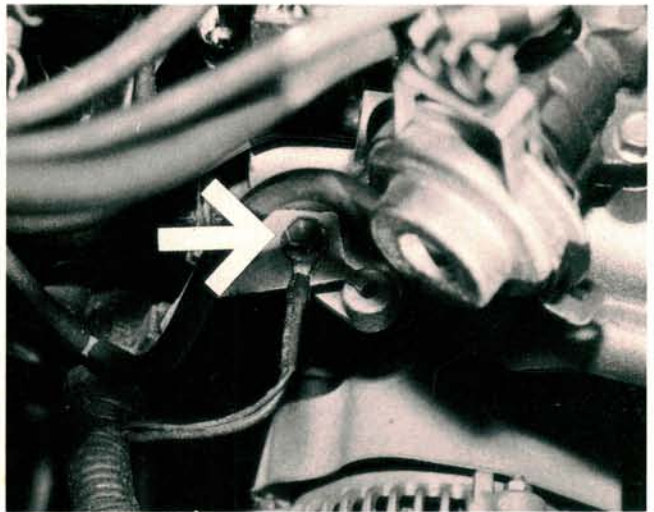
Loose Isuzu I-Mark ECM Ground Connection

A loose or corroded ECM ground wire connection (arrow) on non-turbo 1986-88 Isuzu I-Marks can cause a false Trouble Code 13 (defective oxygen sensor) or Trouble Code 44 (lean engine condition) to be displayed. The loose ground may also cause the "CHECK ENGINE" light to flash intermittently with the engine running. Turbo models have two ECM ground wires in the same area. Remove the plastic cover (if so equipped) and the bolt, clean the wire terminal end, then torque the bolt to 8 Nm (6 ft-lbs).

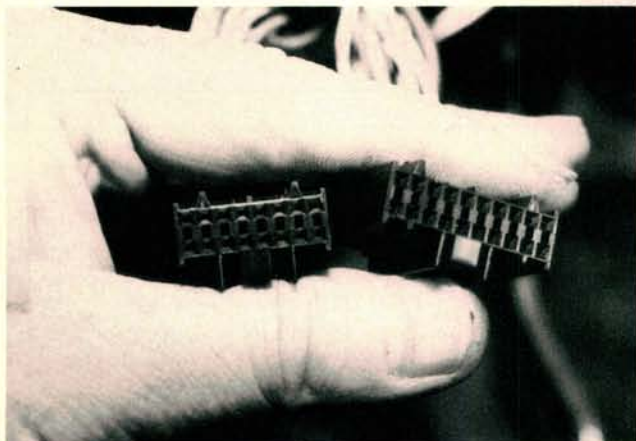
Multi-pin Connector Diagnosis—Subaru

I'm sure by now you've come to hate the word intermittent. Multi-pin connectors like these used on a Subaru ECU are a good source of intermittent electrical problems. Maybe the connectors snap together just fine. But are you sure the twenty or so terminals inside the connectors are making good electrical contact? Unplugging and replugging the connectors might cure the problem, temporarily. Many electrical parts are mistakenly replaced when the terminals inside their connectors are really at fault.

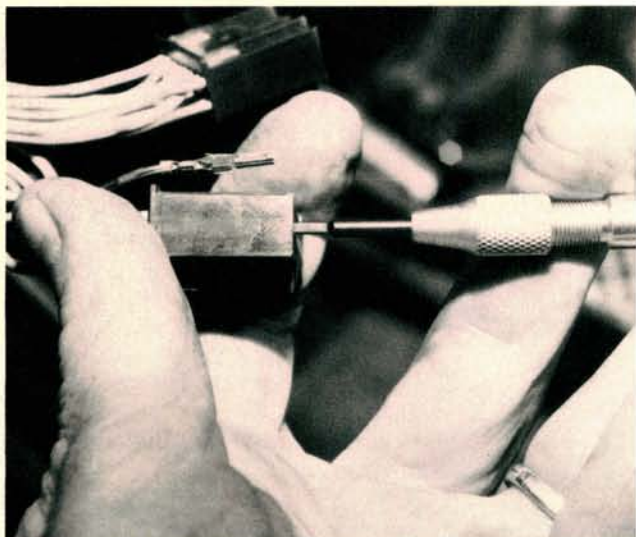
Sliding Resistance Test—Subaru

Remove one terminal. Then remove its mate from the opposite connector. Plug the two terminals together, then measure their sliding resistance by checking how easily they are pulled apart. A loose fit may result in an intermittent connection when both terminals are back in their connectors. Carefully tighten a loose fitting female terminal end before reinstalling both terminals in their connectors. Move on to the next pair until all the terminals in the problem circuit have been tested.

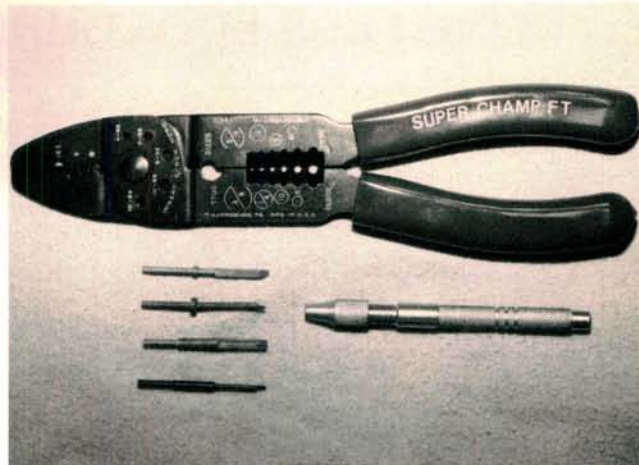
Pin Vice and Crimping Pliers—Subaru

Subaru has recognized this problem and now offers this set of tools to safely remove individual terminals from their connectors. Four different tips for the pin vice will handle several types of connectors used on Subarus and other vehicles. It beats digging around inside a connector with a pocket screwdriver trying to release a terminal. And if you damage the locking mechanism, the terminal may back out later. The crimping pliers are used to replace damaged terminals.

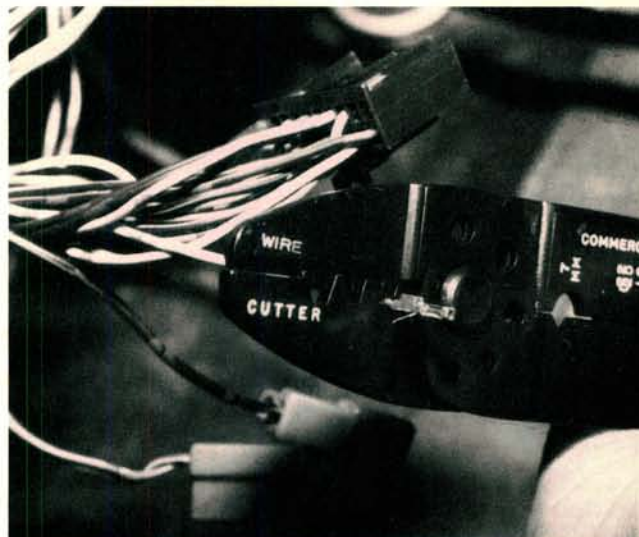
Replacing Terminal Ends—Subaru

Subaru also offers two assortments of terminal ends to replace damaged terminals used on models produced since 1983. Don't try to use an ordinary wire crimping tool to replace these ECU terminals. Only a crimper with these square jaws will make the proper crimp on the terminal end. The Connector Remover Kit P/N SOA636414, Crimping Pliers P/N SOA475T100, and Terminal End Assortments A: P/N 81072GA140 and B: P/N 81072GA150 are available through Subaru parts departments.

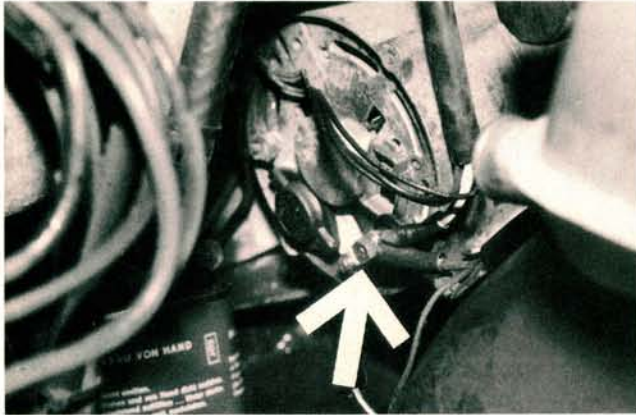
Grounding Saab Alternator Positive Terminal

Saab 900s beginning with the 1981 model year have the alternator mounted low on the left rear side of the engine. The positive terminal may extend beyond the surrounding insulator block. Some alternators have no insulator block, leaving the terminal exposed to accidental grounding. Keep tools clear of the terminal during oil changes. The transmission kickdown cable on automatics and the radio suppression wire found on 1986-87 models should also be tiedrapped to avoid contact with the terminal.

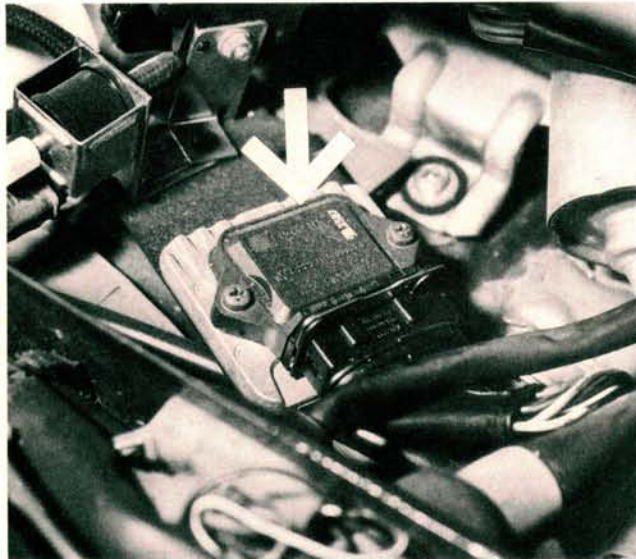
Volkswagen Ignition Control Unit

An intermittent stalling problem on Volkswagens equipped with this Hall effect ignition control unit (arrow) may be caused by metal shavings trapped between the unit and its heat sink. The shavings warp the control unit as its mounting bolts are tightened. This may distort and damage the control unit's integrated circuits and cause an intermittent stalling problem as the unit and heat sink heat up. Clean the control unit and heat sink, then reinstall the control unit.

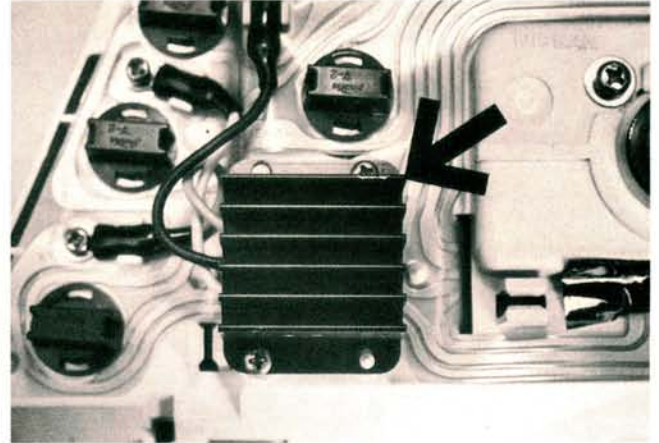
Nissan Dash Gauge Voltage Regulator

The voltage regulator mounted on the dashboard printed circuit of 1987 Nissan Sentras has caused some problems. Nearly all the early non-heat-sinked voltage regulators have either failed already or will eventually. If the fuel and temperature gauges are both inoperative, you can bet the regulator has gone South. Nissan has offered extended warranty coverage to repair failures. The silver colored voltage regulator caused the headaches. The black, heat-sinked design (shown) holds up a lot better.

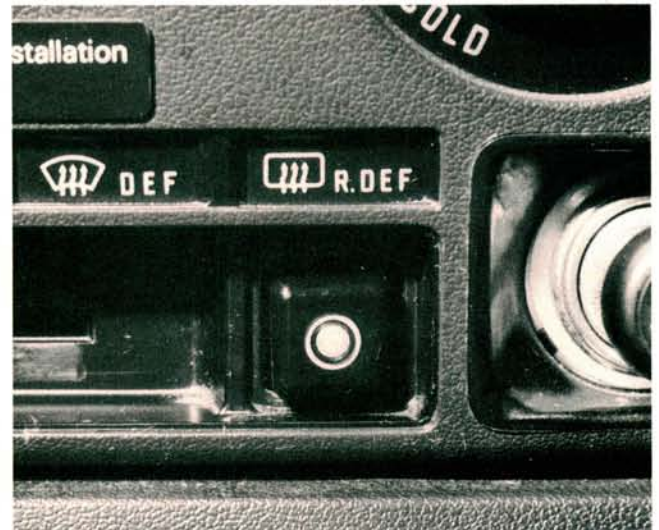
Mystery Battery Discharge

When diagnosing a discharged battery with no apparent cause, check the rear window defogger circuit. The defogger draws heavy amperage, and some imports don't use a timer to turn the defogger off. The battery may become discharged if the defogger is left on for long periods and the car is driven only short distances at low speeds with the air conditioning and other accessories on too. Honda has a replacement Switch/Timer Assembly P/N 35500-SEO-A11 for 1986-87 Accords with this problem.

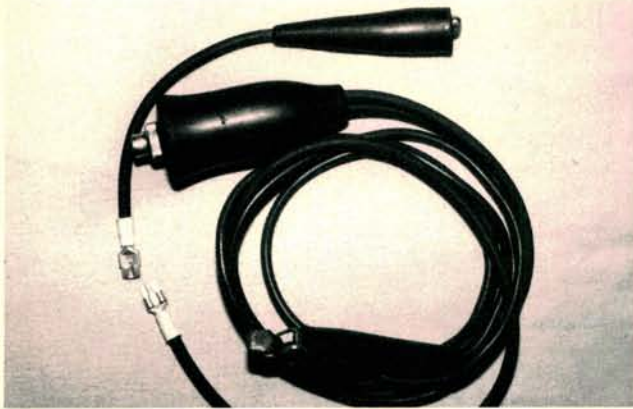
Remote Starter Switch Modification

Starter solenoid terminals are often located in hard to reach, out of the way places. It's pretty frustrating to get half way through a valve adjustment and have the alligator clip on your remote starter switch fall off the solenoid terminal. This can be avoided by installing an insulated female spade connector on one wire of your remote starter switch. By installing a male spade connector on the 8-10 inch section of wire you've just removed, both alligator clips can still be used when needed.

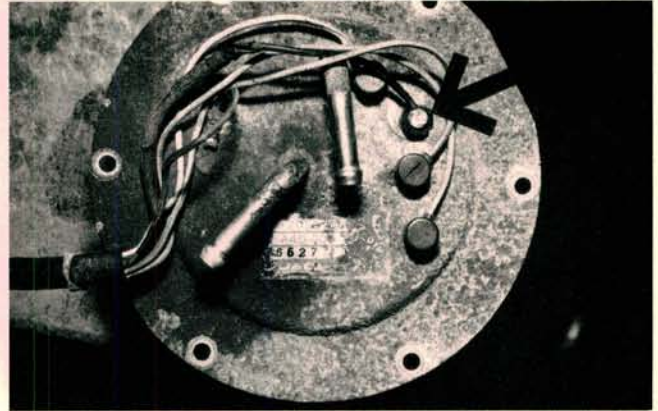
Nissan Fuel Pump Wiring Corrosion

The soldered wiring terminals for the in-tank fuel pump on 1984-88 Nissan 200SXs can cause a variety of problems. This unit had a corroded ground terminal (arrow). The insulation had split around the ground terminal, which let the fuel pump ground through the metal of the sending unit. The ECU controls the fuel pump through its ground circuit, so the pump ran with the key off. Corroded terminals can also cause an intermittent stalling condition. Replacing the sending unit is the only sure fix.
