Out Of Range Rover

I received a call the other day from a shop owner who wanted to inquire about some fuel injector connectors. As we were talking, the shop owner said "Oh by the way, can you help me with a 1987 Range Rover that intermittently runs very rough, floods, and won't restart?" I told him I'd be glad to try, and so the story begins.

—By Lester Bravek

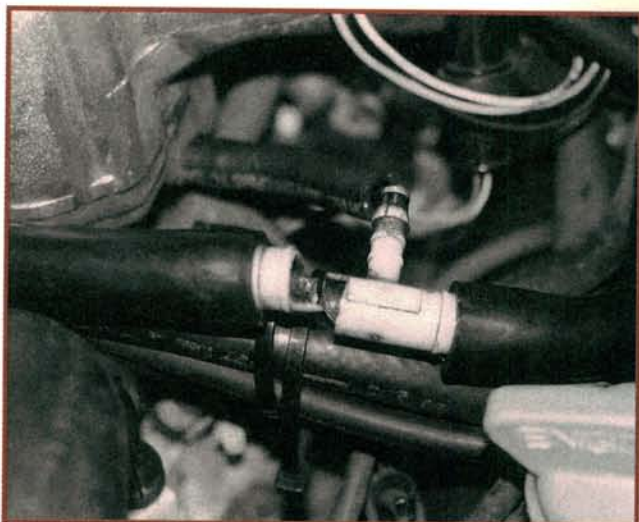
1 We're just getting started, so a visual inspection should take first priority. This will often allow you to quickly solve a problem. In this case, we spotted several little problems and improved the engine's idle quality, but the original symptoms still returned. At idle, the engine sounded anemic and a vacuum leak was evident (this broken vacuum connector was to blame). The last person to work on the Rover attempted to adjust the system without diagnosing the underlying problems.

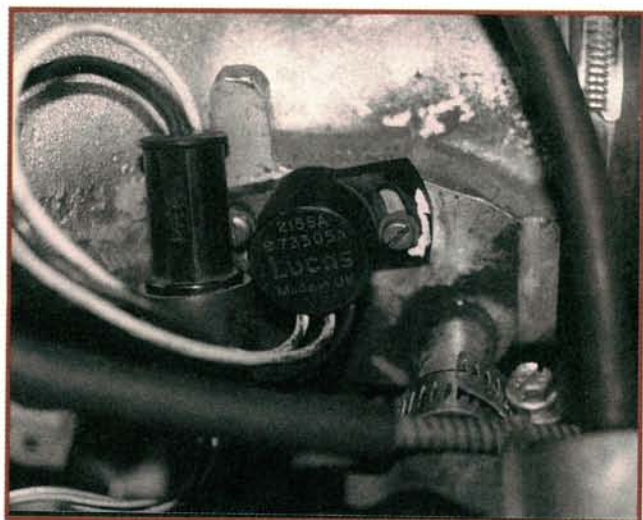
3 It appeared that the TPS sensor had been adjusted to 2.2 volts in an effort to compensate for the Rover's running problems. The high TPS voltage would explain why the vehicle was running rich with a high idle speed. Also, the high TPS setting was covering up the vacuum leak we discovered earlier. I initially adjusted the TPS to 0.5 volt and proceeded with our diagnosis. We later learned that the correct TPS voltage value should be 0.325 volt with the throttle fully closed.

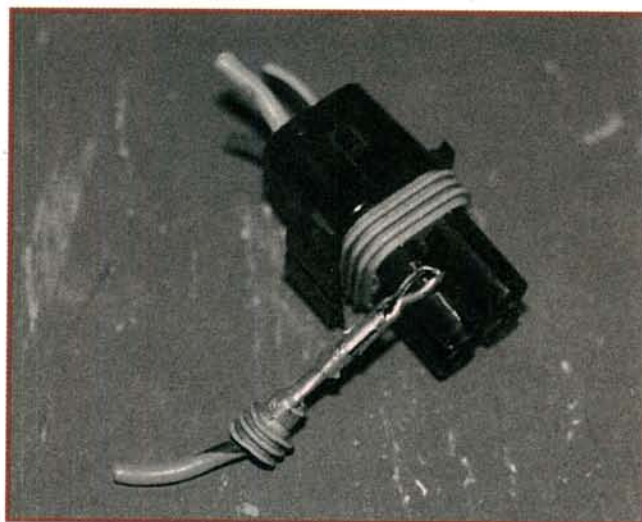
4 Here's another cause for our high idle. The engine was idling at 1500 RPM with the idle screw turned all the way into the throttle housing. We found a bent and recessed terminal inside the idle speed control motor harness connector. This four terminal Weatherpack connector may be familiar if you work on GM vehicles. We replaced it with a new connector and terminals. Without a properly functioning ISC, the vehicle had no cold engine idle compensation, and ran at 700 RPM.

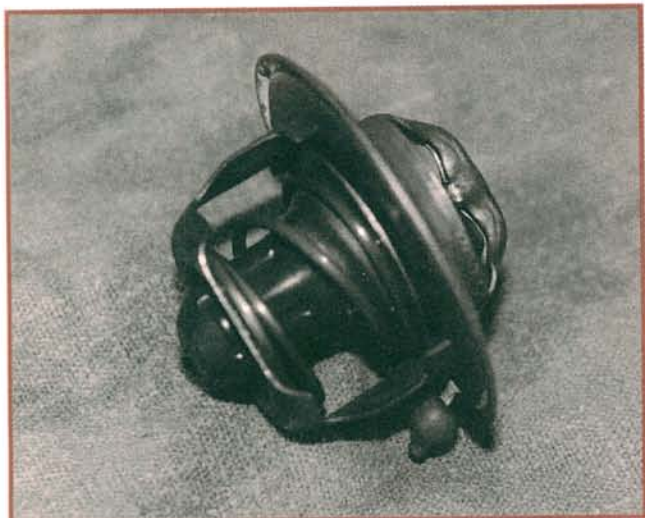
5 While driving the vehicle, we noticed that the instrument cluster temperature gauge never registered a warm engine. This looked like another potential cause for our rich running condition. The thermostat was stuck open, which kept the engine from reaching operating temperature. The coolant temperature sensor's output voltage never dropped low enough to signal the ECU of a warm engine condition, which also contributed to the rich running condition.

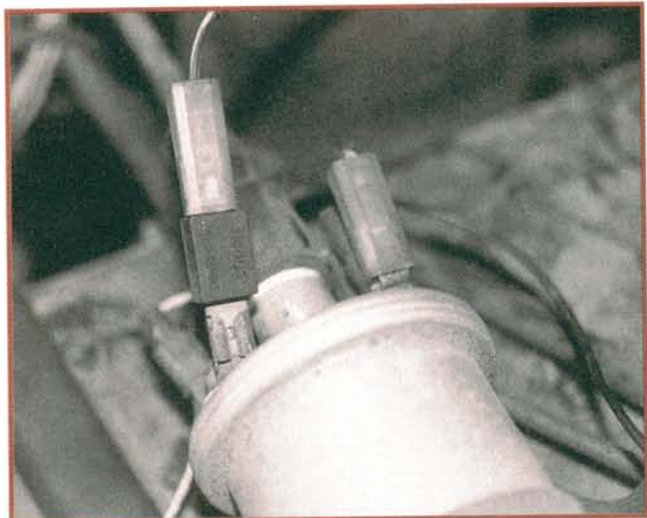
6 Ignition timing is not controlled by the ECU, but the ECU does receive RPM-based information via the minus side of the ignition coil. The black spacer pictured above is a 6.8 K ohm dropping resistor which is connected in series with pin 39 of the ECU. This resistor was inspected for any visual signs of cracking. An open in this resistor could contribute to a no-start condition. This input brings the ECU to life and tells it to start processing sensor data and compute injector ON time.

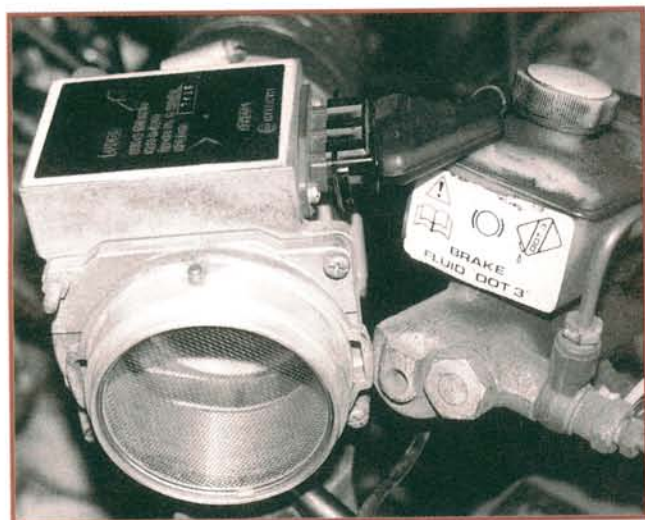
7 Although my experience with AMM (air mass meters) has shown that they rarely contribute to a rich running condition, we gave the meter a visual inspection. We pulled off the connector and inspected the terminals for any signs of corrosion or damage. A look inside showed an open bore with a mesh screen covering the opening. The sensing element is hidden out of harm's way inside a sampling port, which runs parallel to the incoming air flow in the main air passage.

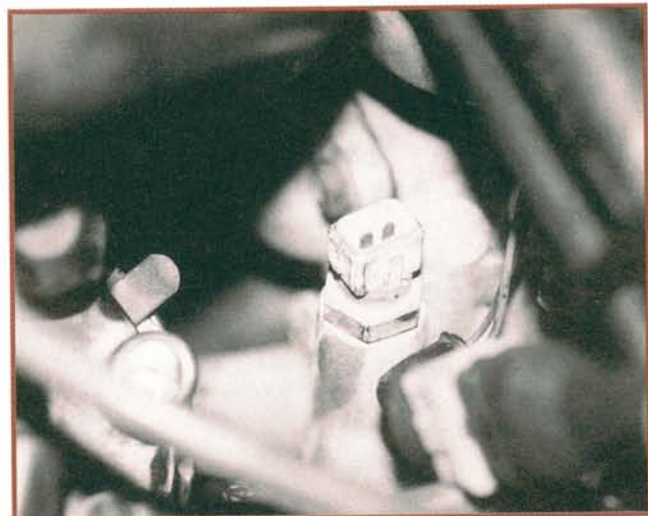
8 While the engine was cold, we measured a coolant sensor reading of 3.5 K ohms resistance, and a 3.2 volt output with the sensor connected. We set the DMM on MIN/MAX voltage, then started the engine. As the engine warmed, the voltage slowly dropped to 1.1 volt, then started to climb. The vehicle started to stumble and a check of my MAX reading showed the sensor output had reached 3.9 volts! Now we had an answer to the intermittent stumbling and flooding during hot restarts.

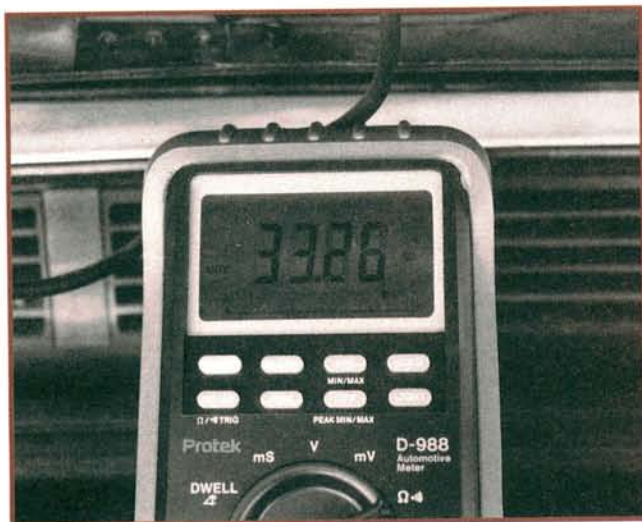
9 Next we shut the engine off and measured the resistance at the temperature sensor to make sure the voltage fluctuation wasn't coming from a bad electrical connection between the sensor and the ECU. As this photo shows, the resistance at the sensor had climbed to 33.26 K ohms, indicating that the engine temperature was below zero. It was clear at this point that we had found the main cause of the driveability problem, and discovered a bunch of other problems as well.

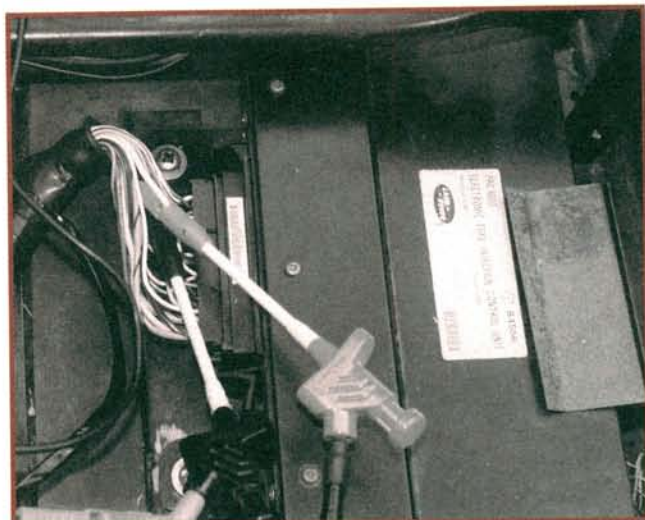
10 The ECU is located under the front seat, which required removal in order to gain access to the 40-way connector. This allowed us to check all the inputs and outputs right at the ECU, and inspect the condition of the connectors inside the plug for any signs of damage. We also checked for any bad power or ground connection problems. While test driving the vehicle, we were able to measure coolant temperature, AMM, and injector ON-time, all while seated inside the vehicle.

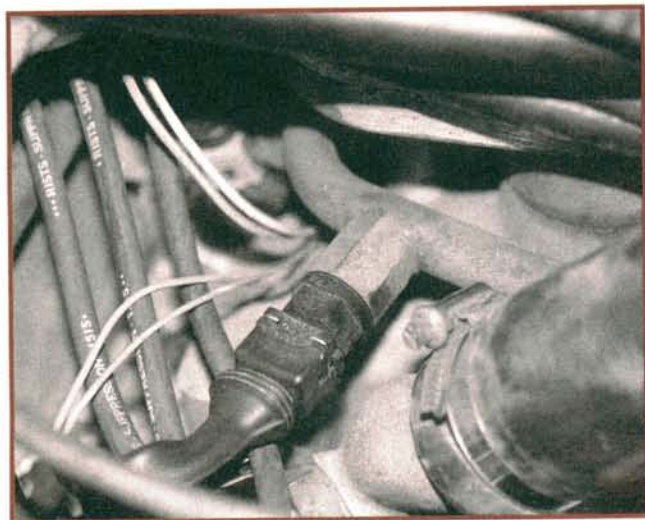
11 The system has a fuel temperature sensor housed inside the fuel rail at the front of the engine, near the thermostat housing. The sensor produced a 2.5 volt output with an ambient temperature of 70 degrees F. Disconnecting the sensor did not seem to affect engine idle quality or running condition. Don't confuse this sensor with the engine coolant temperature sensor, which uses the same style connector and is located behind the thermostat housing to the right of the fuel temperature sensor.

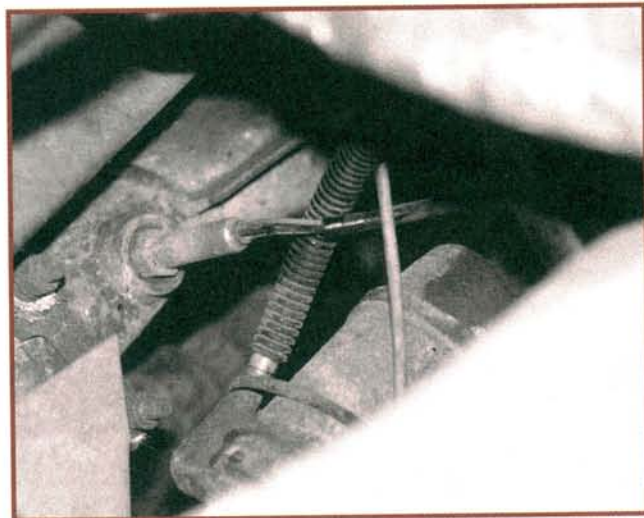
12 The Rover's V8 engine has a pair of three wire heated O₂ sensors, one for each side of the engine. The harness connectors for the O₂ sensors are located behind the engine along the firewall and are not easily accessible. Always check the internal resistance of the O₂ sensor heater elements, and make sure they are getting power and ground. This will ensure proper H₂S operation and will allow the system to enter closed loop, once all the other sensor input conditions have been met.

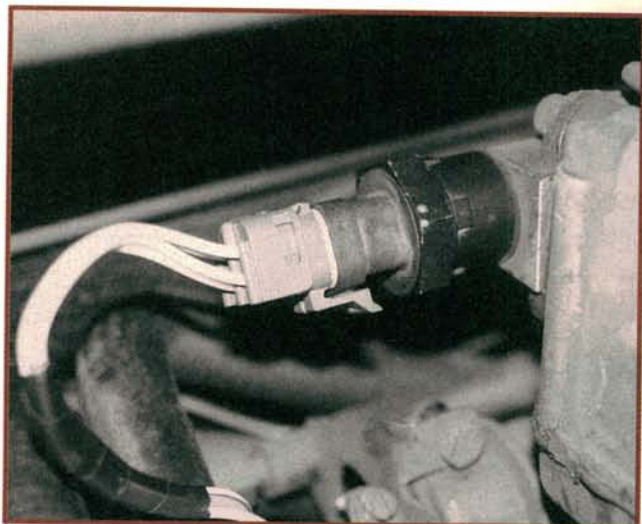
13 1987-89 Range Rovers equipped with 3.5 liter V8 engines and LH 40 engine management systems have no fault codes that are accessible without specialized equipment. If the Check Engine light is illuminated, any of four engine management sub-systems may be out of parameters. They are: TPS, idle speed stepper motor (ISC), AMM, or coolant temperature. The factory hand-held diagnostic tool plugs into the four wire diagnostic socket located inside the engine compartment to read these faults.
