## Great Tips

Welcome to the 1997 *Import Service Tech Tips Special*. Here you will find a wide assortment of tech tips on a variety of import vehicles. As we have done in the past, we have divided your tips into eight basic sections. They are:

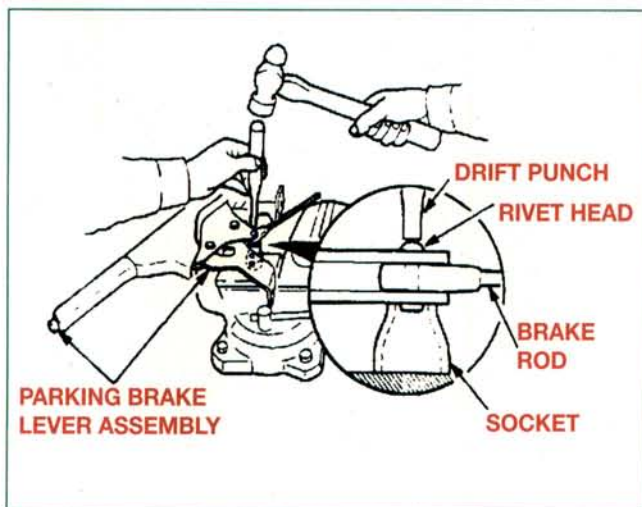
Some 1993-94 Honda Accord and Prelude models may experience premature rear brake shoe wear due to a binding parking brake handle. This condition does not allow the rear shoes to completely release and the red brake warning light may also remain on.

To repair this problem:

- Remove the center console, the parking brake rod from the equalizer, and the two bolts retaining the parking brake handle assembly.
- Remove the assembly from the vehicle and place it on its side.
- Place an 8 mm socket over the rivet, from the opposite side.
- Center a  $\frac{3}{16}$ -inch drift punch over the top of the rivet, then tap with a hammer (refer to figure).

This procedure will allow the parking brake handle to move more freely. After reinstalling the handle assembly, re-adjust the cable at the equalizer, verify that the parking brake is functioning properly, and that the red brake warning light is off when the handle is down.

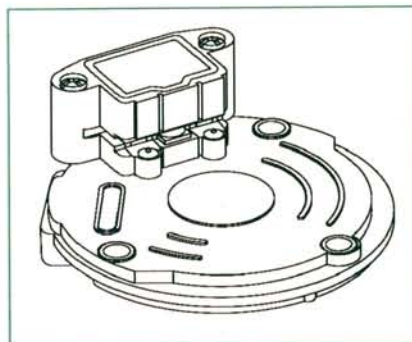
An erratic spark and fuel injection control condition on mid-eighties Nissan vehicles that goes away as the vehicle warms up may be caused by the presence of oil on the optical crank angle

assembly. These symptoms may occur on 1982-89 Nissan models equipped with 3.0 liter V6 engines, as well as 1984-87 Nissan models equipped with 1.6 liter four cylinder engines. They may also occur on vehicles from other manufacturers that are also equipped with optical crank angle sensors.

The loss of signal may also be caused by internal cracking on the optical trigger assembly main board. In this situation, the vehicle will operate normally when first started, then become erratic as the engine warms. As the engine reaches normal operating temperature, the engine may smooth out. In this instance, cracks or cold solder joints on the crank angle sensor optical board are usually responsible. Replacement of the optical trigger assembly is the recommended service.

Short term servicing is as simple as removing the interrupter plate, then cleaning the emitter and collector using a swab and glass cleaner. Long term repairs should include servicing the distributor shaft bearings and seals.
