Saab Transaxle Repair

PART ONE

—By Karl Seyfert

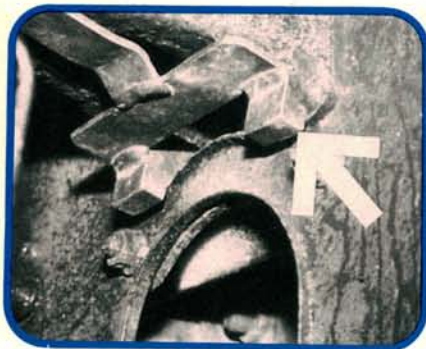
1

Engine and transaxle removal could be an article all by itself. If you're a first timer, consult a service manual for more detailed information. Remove the right front wheel; then raise the lower control arm with a jack. Placing this tool (arrow) under the upper control arm unloads the lower ball joint.

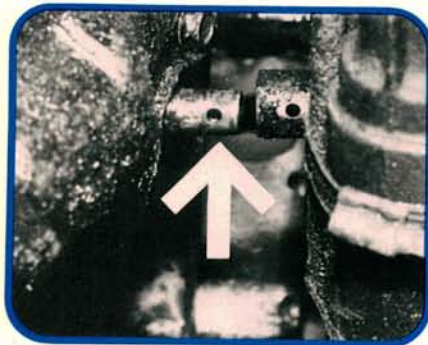
3

The engine and transaxle can be removed after moving the right front suspension. It's a close fit and involves some wiggling. The engine and transaxle must be pushed to the right to clear the left axle tripod joint before the engine can be lifted. Drive out the pin and separate the shift linkage (arrow).

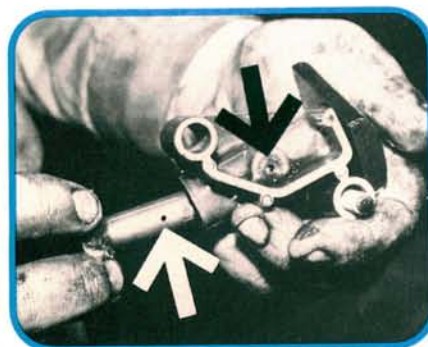
7

Remove the chain tensioner. Note the small hole (white arrow) in each tensioner piston. These must face the rear for proper tensioner operation. The tensioner check ball (black arrow) should move freely. Use thread sealer on the tensioner bolts during installation to prevent oil leaks.

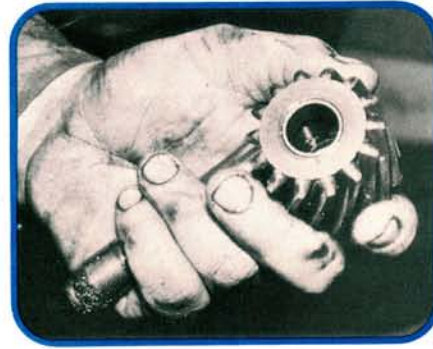
14

Remove the reverse idler gear and give it a close inspection. If the customer has been doing rolling-reverse engagements, the ends of the teeth may be getting a little iffy. These still looked pretty good after almost 100,000 miles.

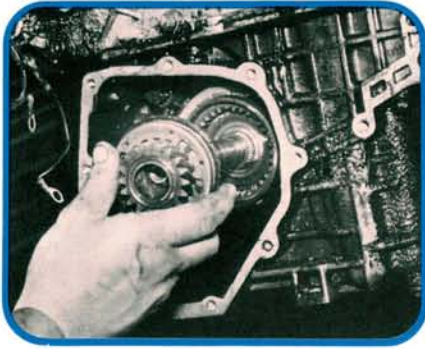
23

Remove fourth gear and its synchronizer assembly. Remove the three-four selector shaft. Take out the three-four synchronizer hub, sleeve, and selector fork. Inspect the sides of the selector fork for wear in the area where it rides on the synchronizer sleeve.

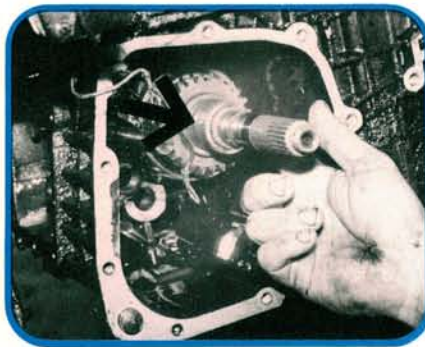
25

Continue removing gears, shift forks, and bearing races. A pointed, hooked seal puller will fit into the oil holes of the gear races (arrow). Tap the seal puller carefully to remove the race if it's stuck. Move to the opposite side of the race if it begins to cock on the pinion shaft.
