Toyota 20R Timing Chain

Toyota's workhorse 20R and 22R series engines have been with us for a long time. The 20R was first used in 1975 model Coronas, Celicas, and pickup trucks, and stayed in service until it was replaced by a larger, modified 22R engine in 1980.

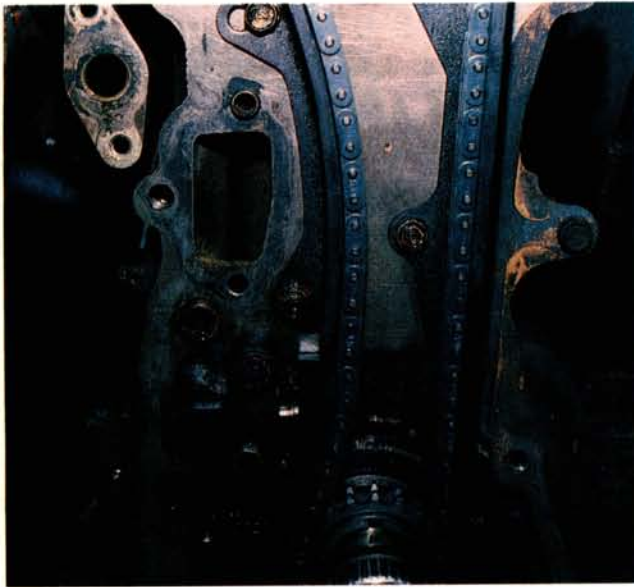
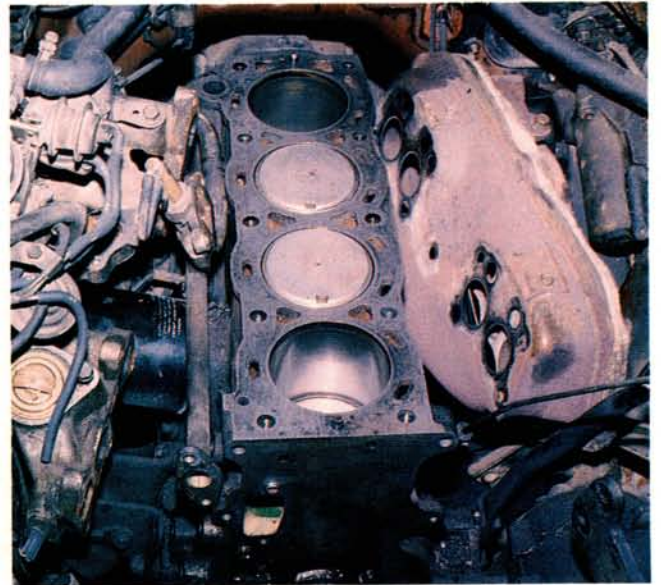
The 20R used a double row timing chain that was virtually bulletproof. And even after the 22R went to a single row chain, many techs chose to retrofit early 22R engines with the 20R double row chains and sprockets. Finally, Toyota put an end to that fun by changing the front timing cover and removing two links from the chain in 22R engines produced after August 1984.

Both the double and single row chains before the change had 98 links. The modified single row chain had 96 links, not to mention that the new, modified timing cover was too shallow for a double row chain anyhow.

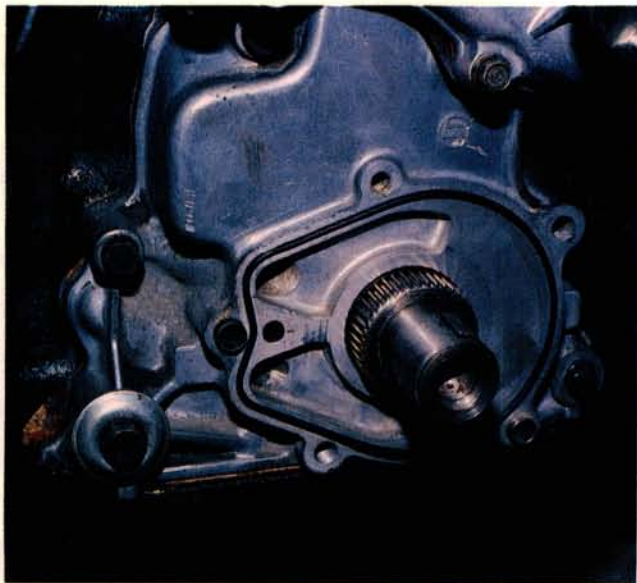
We're going to tackle an old 20R. The procedures involved in checking and replacing the timing chain and gears are similar to those of the 22R.

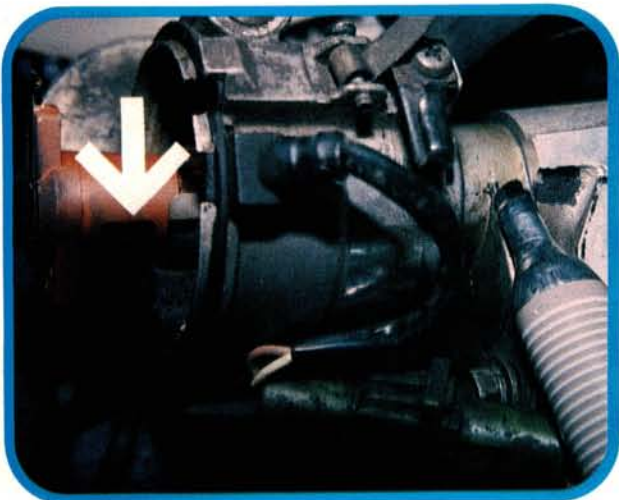
Save some reassembly time by turning the engine to TDC on number 1 cylinder and marking the distributor with a felt pen before removing it. Mark the rotor to dust cover position. Mark the distributor to cylinder head position. Later, you can just line up the marks when you reinstall the distributor.

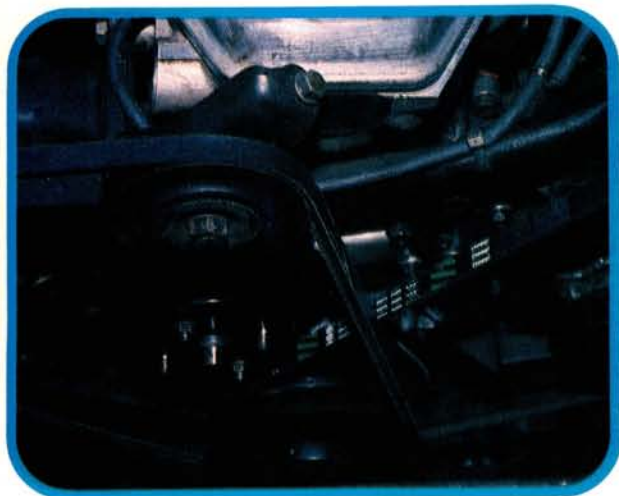
2

Just getting to the timing cover is a chore on this particular engine. Japanese engineers love to cross bolt mounting brackets for added strength. They bolt the brackets to the engine timing cover, cylinder head, and block, with many bolts placed at right angles to one another.

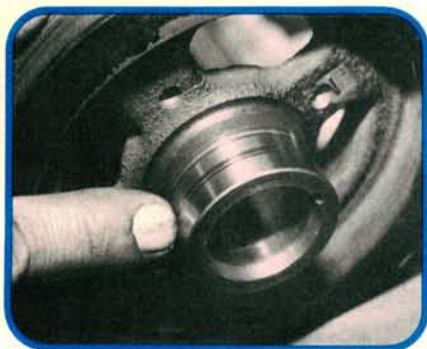
3

Remove the front pulley. Clean it and inspect the surface where the front crank seal rides. Leaking oil from a heat-hardened seal will mix with dirt to form an abrasive paste that will eventually ruin the pulley sealing surface. This pulley showed a small amount of wear, but was reusable.

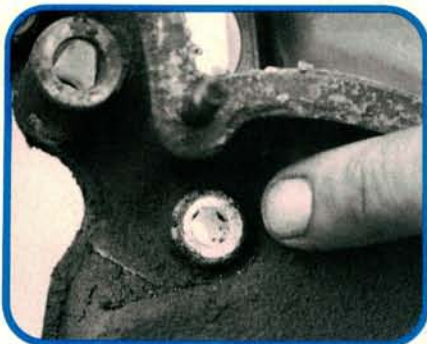
5

There's another hard to find bolt directly below the water pump. It's easy to see in this photo, but just as easy to miss when you're looking down on the front of the engine from an angle. If you think you've got all the bolts out, but the cover still fights back, check again.

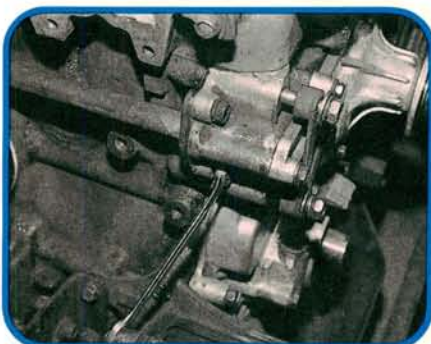
6

The coolant bypass tube also bolts to the timing cover. Please resist the temptation to drive your screwdriver between the timing cover and block when you remove the cover. If you've removed all the bolts, including the oil pan bolts, a few raps with a soft mallet should free the cover.

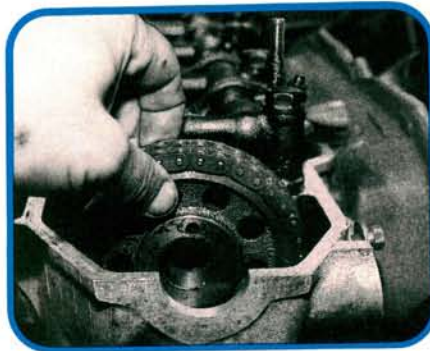
16

The TRW timing chain we used on this engine is a one piece chain. It has no master link. Some manufacturers provide chains with master links to ease installation. The one piece chain was easy to install. Chain and sprocket fit through the opening in the front cover and slipped over the end of the camshaft.

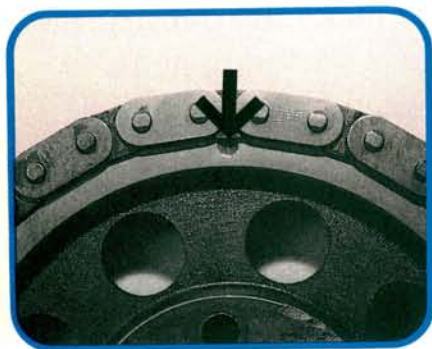
19

Set the camshaft for TDC on number 1 cylinder. The camshaft sprocket locator pin will be at 12 o'clock. Find the two shiny links farther down the chain. Place one link on each side of the punch mark, then slide the sprocket over the end of the camshaft while aligning the camshaft locator pin in the sprocket.

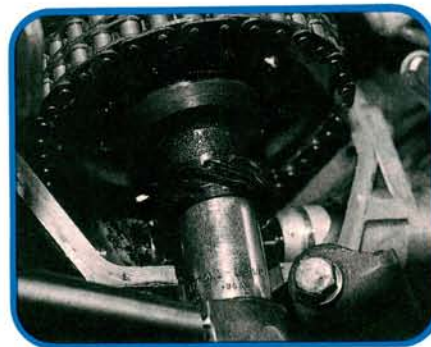
20

Install the chain dampers and tensioner. Torque the camshaft bolt to 78 Nm (58 ft-lb). On 22R engines with a mechanical fuel pump, you'll have to install the fuel pump drive cam behind the bolt. The shop manual doesn't mention putting thread locking compound on the cam or crank bolts, but we will.
