LUNCH BOX COMPANION

Volvo 240 Wiring Harness

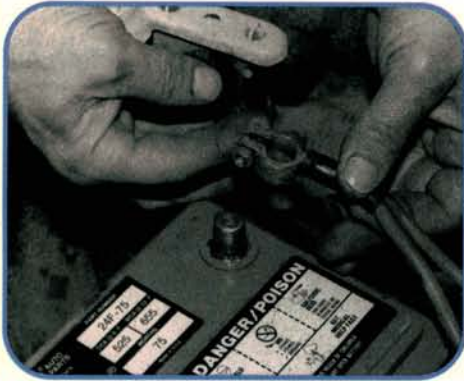
1

We disconnect the battery first thing. If we do have a shorted harness, we'd rather not find the problem area by backtracking to the source of smoke! We also take the time to clean the battery, battery posts and terminal ends for later installation. Every car should get this treatment at least once in its life.

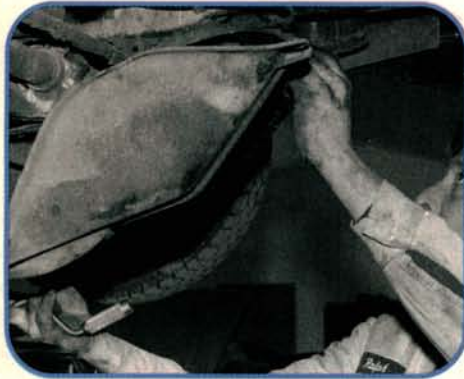
2

Our Volvo is experiencing several intermittent electrical and ignition misfire problems, especially when it rains or when the humidity is high. The front, lower section of the engine wiring harness is often the first to cause the problems we're experiencing, so we drop the engine shield to take a closer look.

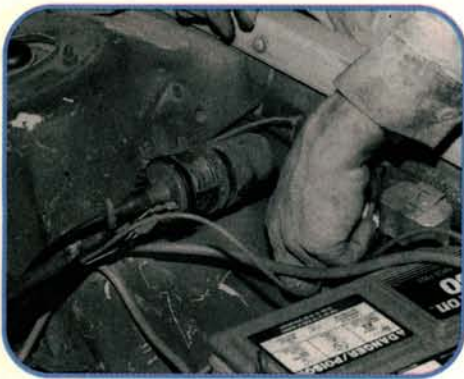
3

How do we know it's an ignition misfire? Why do we suspect the harness? A logic probe attached to the coil tells us that the primary triggers are intermittent, disappearing each time a misfire occurs. But the signal is good at the ignition module. It just isn't getting to the coil on a regular basis.

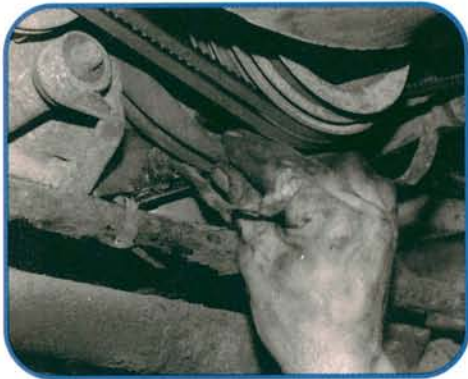
4

This lower harness section contains wires for the ignition module, alternator, and oil sender. Exploratory surgery discloses harness-hardening of the arteries. The insulation on the wires crumbles between our fingers like dried bread. On some cars, repair of this harness section will cure your problems.

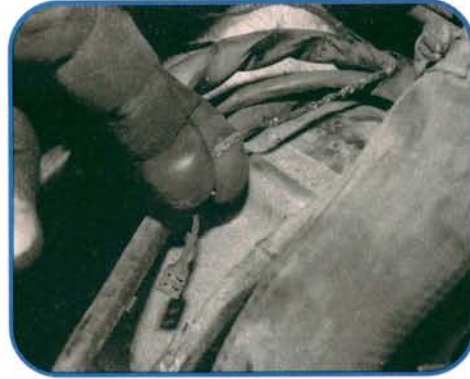
5

We dig deeper. The diagnosis darkens. Down by the alternator, we find bare wires everywhere. The alternator wires and oil sender wire are all bare, and have corroded to a greenish, copper color. We decide to work our way back up the left side of the engine and open the harness in several more places to check it.

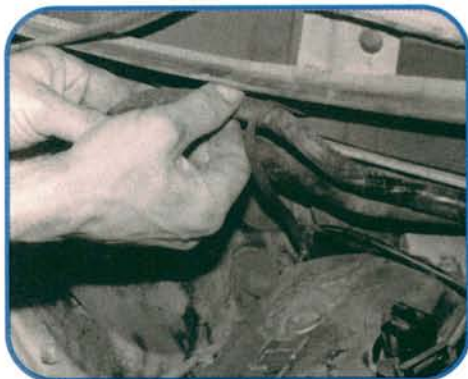
6

When we continue to find the mummified remains of wiring in the harness section at the firewall, replacing the entire harness becomes a logical step. The Volvo's owner digs into the money he's saved on car washes, deciding that a new harness is a fitting recompense for the Volvo's years of service.

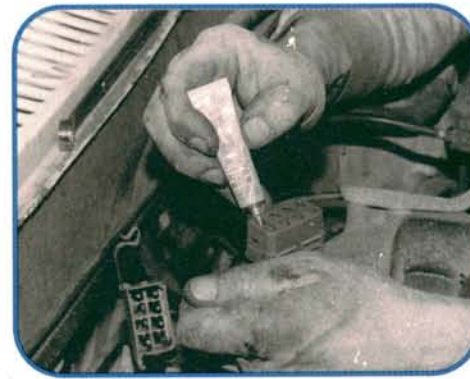
9

There's an eight hole plug coming in from the left side of the firewall that connects to the main harness. These can come apart "real hard." You may get tempted to pull on the harness wires, but please don't. Once apart, a dousing with contact spray and a dab of dielectric grease on each pin does it right.

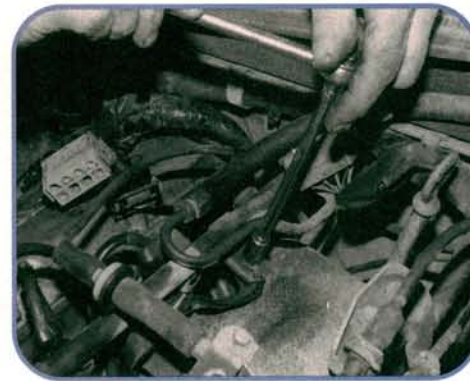
13

Harness grounds are very important. Clean the ground contact areas on the manifold. Use fresh bolts and washers if necessary to ensure a good, long lasting connection. (And the main battery ground cables on the Volvos weren't oversized to begin with, so check them and their connections, just to be safe.)

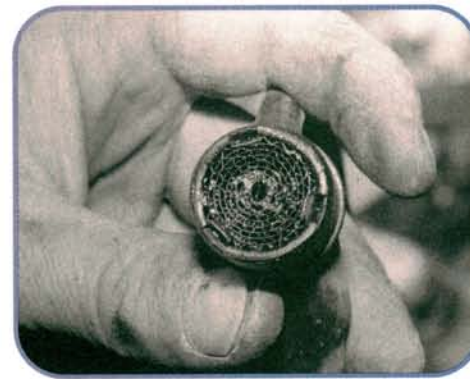
15

While you're under the manifold, treat the Volvo to one other non-electrical service. Yank the flame trap insert. Replace it or flush out that pound and a half of crud that's accumulated in its coils. Maybe it'll slow down all those oil leaks that have my hands looking like a printer's apprentice at the moment.

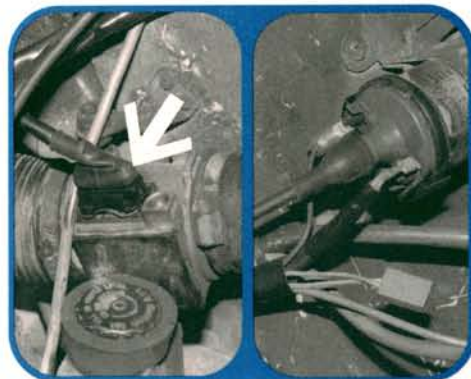
17

Here are installed views of those connectors. (the air flow sensor at the left.) Coil terminals (right photo) are marked as terminal 1 (coil negative) and terminal 15 (coil power). Our coil terminals are brown with corrosion. We unbolt them, and attack everything with a wire brush and contact cleaner.

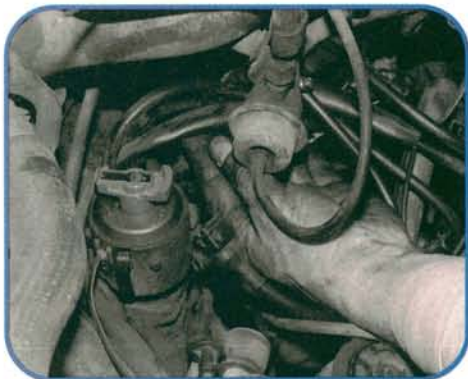
18

As you work your way toward the front of the engine, you'll find that moving a few things out of your way makes life a lot easier. At this point we've removed the cap and wires, the idle stabilizer and its hoses, and the main hose between the mass air sensor and throttle body, just to make some room.

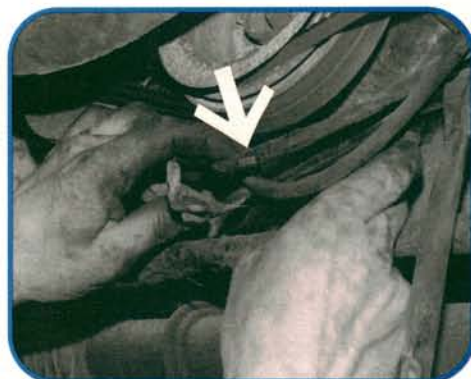
19

Snake the harness down the left side of the engine and route it down around the curve of the oil pan, behind the crank pulley. There are more colored bands on our harness which should help you position the harness. Just line up the metal fastener wrap-arounds with the bands.

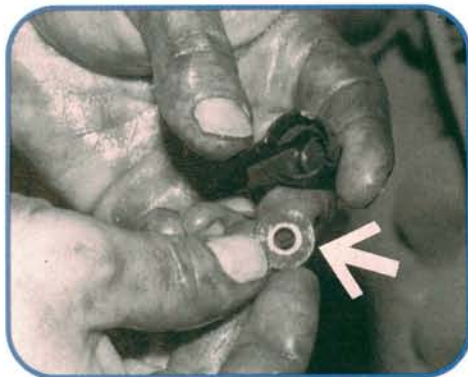
20

When you make your connections at the alternator, don't throw away this washer. It bolts to the alternator B+ terminal, and the protective cap in our greasy fingers snaps over it. A lot of cars show up with the cap long gone because the washer wasn't installed.

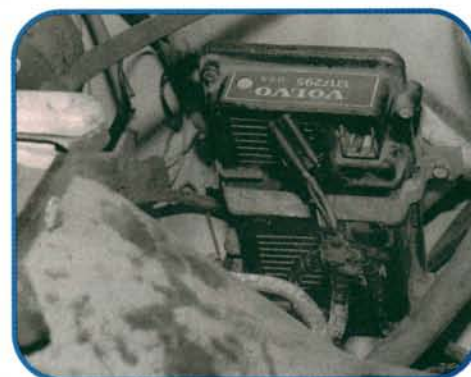
21

End of the line, and the reason this whole adventure started. The last stop on the harness express is the connection at the ignition module. Now that we've restored local service to the ignition coil, the module won't need to call collect and suffer through a poor connection as it tries to conduct its business.
